**Coral Relocation Project in Kaneohe Bay, Oahu, Hawaii**

**Report on Phase I**

**Coral Reef Assessment and Monitoring Program (CRAMP)**

**April 22, 2005**

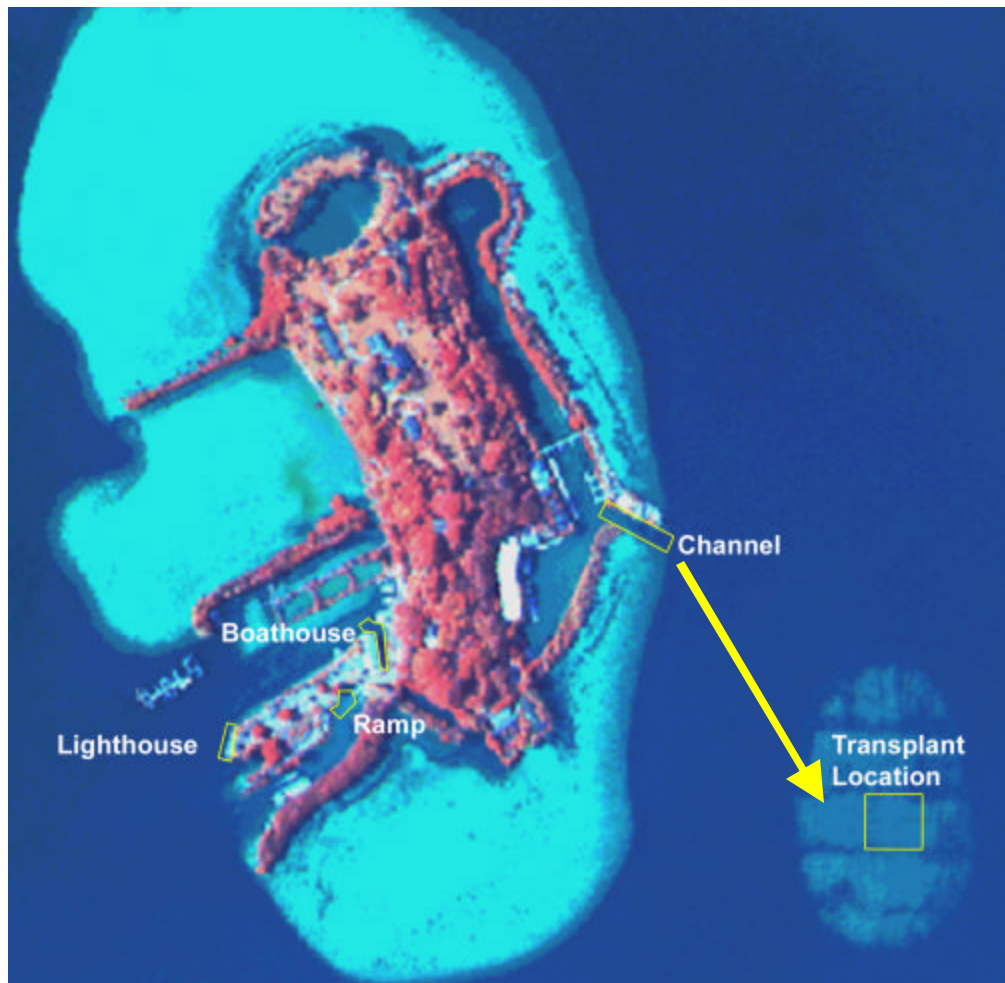
**Figure 1.** Aerial photograph showing location of the source area (channel) and the transplant location for the corals during Phase I of the project.

During Phase 1 of the project corals that had grown to the point that they were blocking the main navigation channel were removed and transplanted to the dredged patch reef (Fig. 1). The coral was moved by the U.S. Army divers. Care was taken so that no invasive algae are moved with the corals to the new site. The corals were placed in a large basket suspended under a boat and moved slowly to the site while submerged (Fig 2). After the corals are moved, scientific divers began to monitor these salvaged corals.

As of March, 31, 2005, live coral was successfully transported from the navigation channel on the NW side of Moku o Lo'e to the dredged reef approved by the Department of Land and Natural Resources-Division of Aquatic Resources and stipulated in the Special Activity Permit No. 2005-25. These locations are shown in Fig. 1. Colonies were gently freed from the substrate with a large pry bar and placed in baskets constructed of soft wire netting to prevent abrasion resulting from shifting during transport. This created a stable platform for

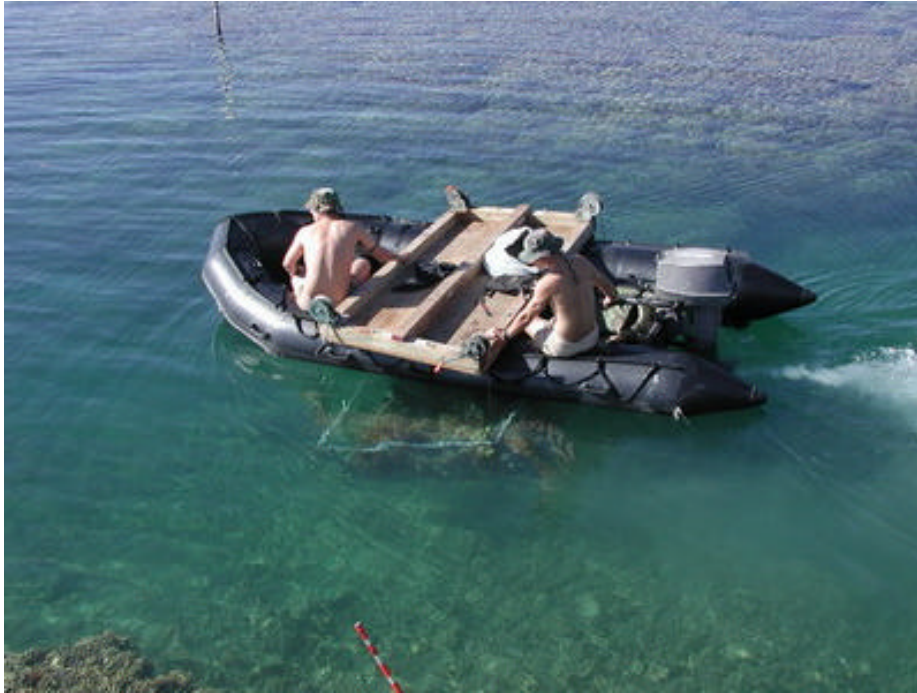
**Figure 2.** Moving corals from channel to patch reef using basket slung under boat with winch system used to lower or raise basket.

transit to the relocation site. Lift bags provided neutral buoyancy for ease of movement. Baskets suspended under inflatable vessels remained entirely submerged during transport to prevent desiccation.

Army divers of the 7<sup>th</sup> Engineering Detachment's 29<sup>th</sup> Engineering Battalion stationed at Fort Shafter, O'ahu, Hawai'i successfully removed all corals blocking the navigation channel. The work was conducted by two groups of divers. The first group of men under the direction of Capt. Scott Miller remained on site from November 30<sup>th</sup> to December 10<sup>th</sup>, 2004, working 12 hr weekdays and 6 hours on Saturday. The second group included 16 men under the direction of Capt. George Mitroka. They worked 8 hrs/day excluding Sundays from March 14<sup>th</sup> through March 24<sup>th</sup>, 2005. During this time over 100 baskets of *Porites compressa* (finger coral) and *Montipora capitata* (rice coral) were relocated to the specified site. This represents an estimated 200 square meters of coral. Each basket contained an estimated 1500 pounds buoyant weight (weight while submerged).

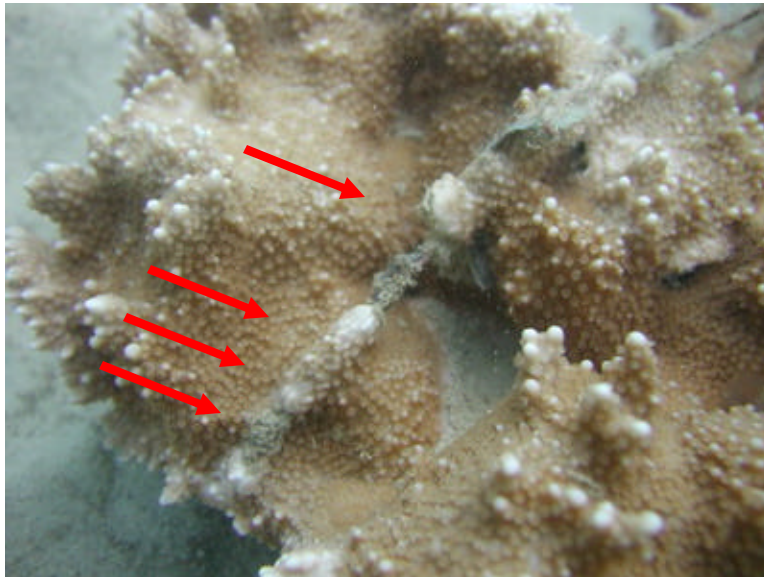
Figure 3. Transplanted rice coral (*Montipora capitata*) that is overgrowing wire used to secure the tag. Photograph taken on April 21 2005.
